INDOOR AIR QUALITY ASSESSMENT

**Alcott Elementary School
91 Laurel Street
Concord, Massachusetts**

Prepared by:
Massachusetts Department of Public Health
Bureau of Environmental Health Assessment
February, 2002

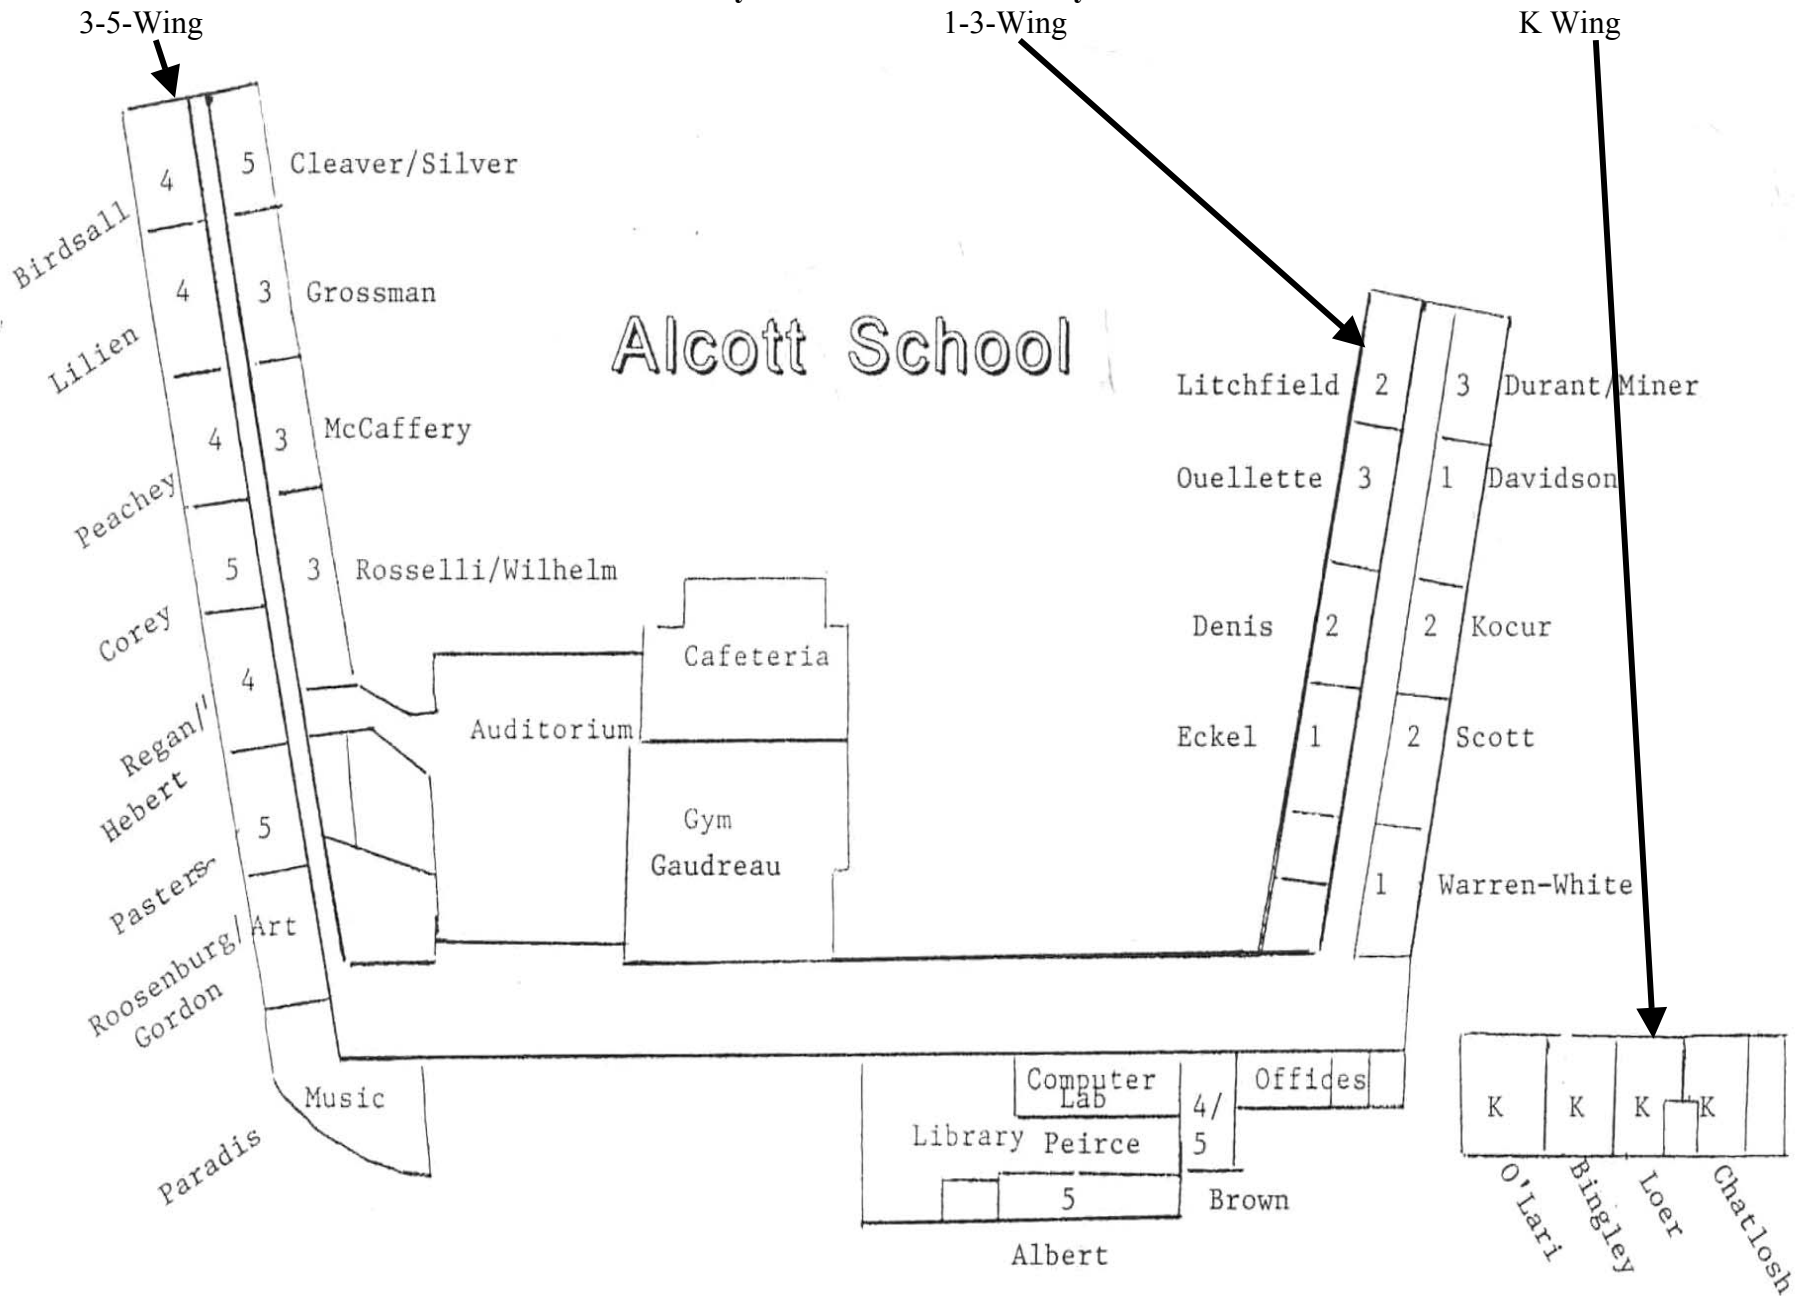
Figure 1
Probable Configuration of Airflow in 1-3 Wing and K Wing

Fresh air is supplied to the 1-3 wing and K wing classrooms by cabinet mounted fresh air diffusers (see Picture 1) that are connected by ductwork to an air handling unit (AHU) in the crawlspace (see Figure 1). All fresh air diffusers were ejecting air during this assessment. In most classrooms, however, these vents were blocked with paper, boxes, books and other obstructions. In order for these vents to provide air, they must remain clear of obstructions.
